# The costs of Non Testing

D. Gillissen  
Stork FDO

# Stork Materials Technology

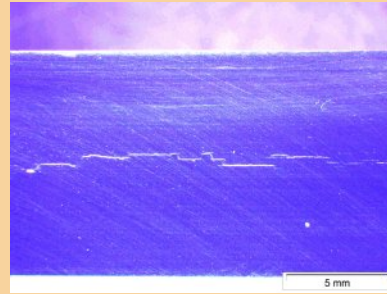
# Example of a pressure vessel

- HIC test for Hydrogen induced cracking
- Test failed
- Vessel subjected to be rejected by the client

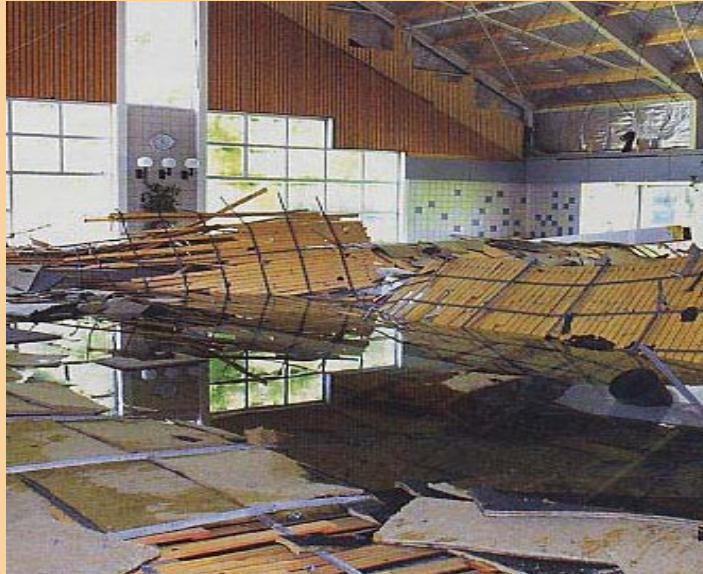
# Situation after incident

In 2001, the suspended ceiling of a municipal swimming pool collapsed. The reason was the catastrophic failure of stainless steel grade 304 fasteners, which had suffered stress corrosion cracking (SCC)

- Inspection of at least 30 swimming pools with the same construction
- Later on more swimming pools were inspected
- Most of the ceiling have to be replaced
- New design criteria had to be made

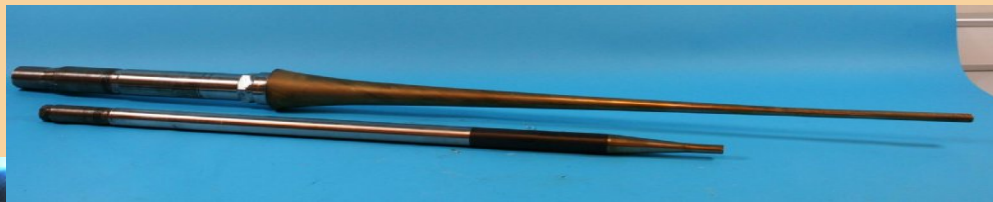
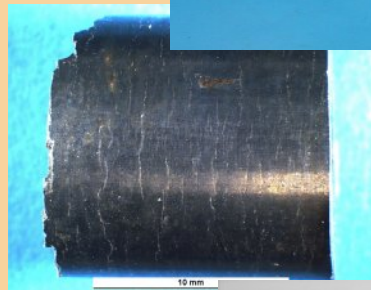
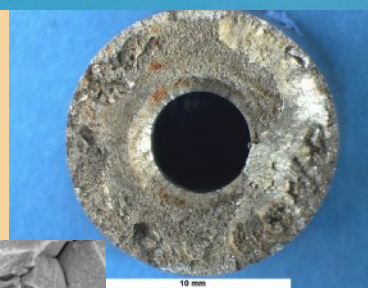
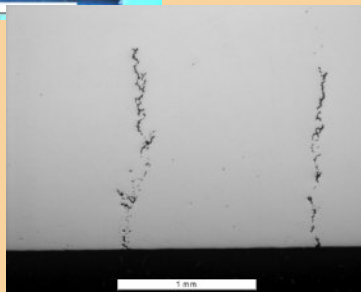
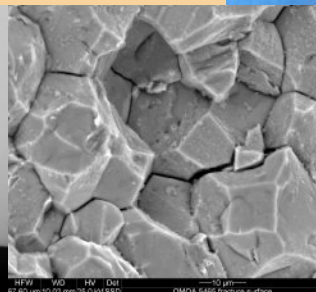
# Designing with stronger materials

- Tension bar in gas handling equipment
- Tension shall be increased to ensure stiffness
- Material with higher tensile strength
- Result failure during test
- Failure analyses shows hydrogen induced cracking from a corrosion process

- High cost for the failure of a very expensive piece of equipment
- Material is not suitable for this application
- Searching for new material
- If no material is available design shall be changed
- Test program for the new selected material

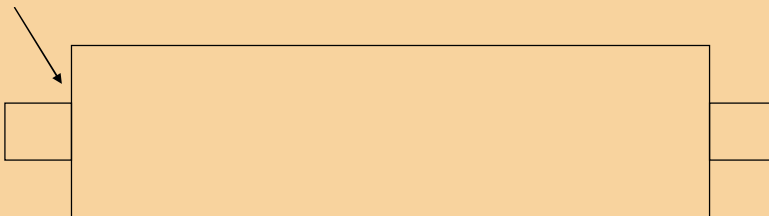
Location of fracture

- Support roll
- Material changed into aluminum
- To improve wear resistance a hard anodizing coating was applied
- Fracture in short time notice

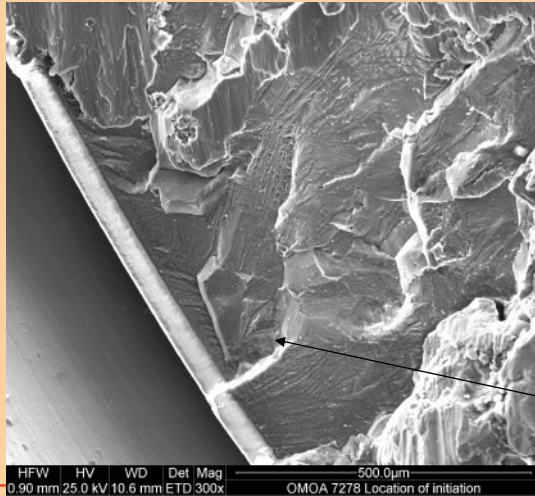
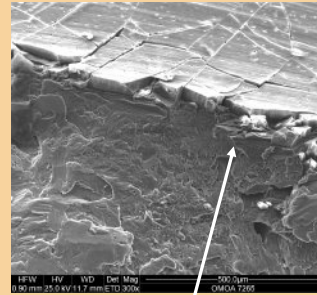
# Examination Scanning Electron Microscope

Initiation point

- Cracks in the hard anodized layer
- Reduction of fatigue strength especially by high strength aluminum after hard anodizing

- Although extensive calculations failure
- Hard anodizing caused a lower fatigue strength as expected
- Testing should have tracked this abnormality
- All produced and built in supports shall be replaced

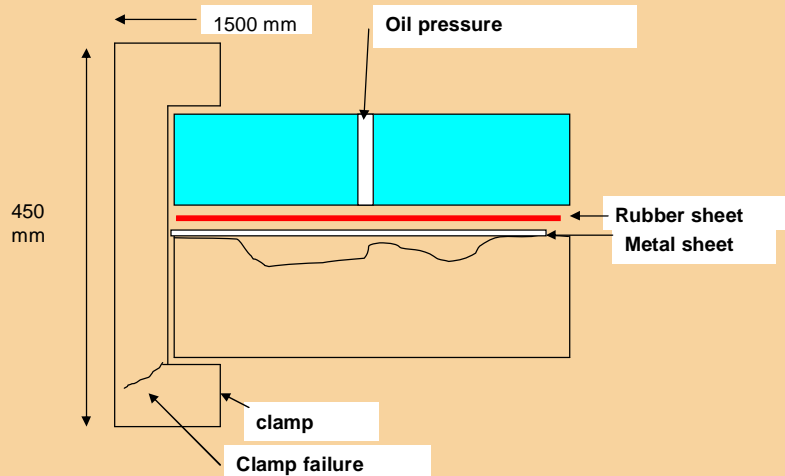
# Example Fluid Forming Press

- First statically calculated two halves
- Failure in two weeks
- Design adapted according finite element analyses
- Key hole design
- Lifetime 3 months

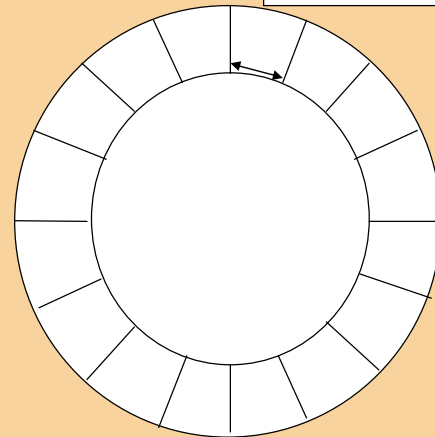
# New design

- Clamp ring built in segments
- Three axial forces are lower
- Lifetime over 10 years
